Inspection Report Minerals Regulatory Program September 17, 2009

Mine Name: Last Chance 25 & 26	Permit Number: M/015/0061
Operator Name: Western Clay Company	Inspection Date: 08/20/2009
Inspector(s): Brett Gregory <i>W H W</i>	Time: 1:00 pm
Other Participants: None	Mine Status: Active

Purpose of Inspection: This was a routine annual inspection to document conditions at the site.

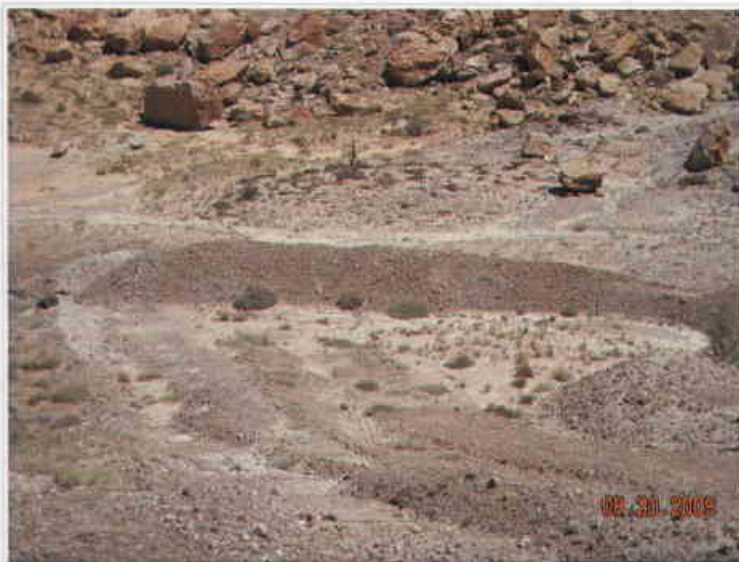
Topsoil salvaged to the north.

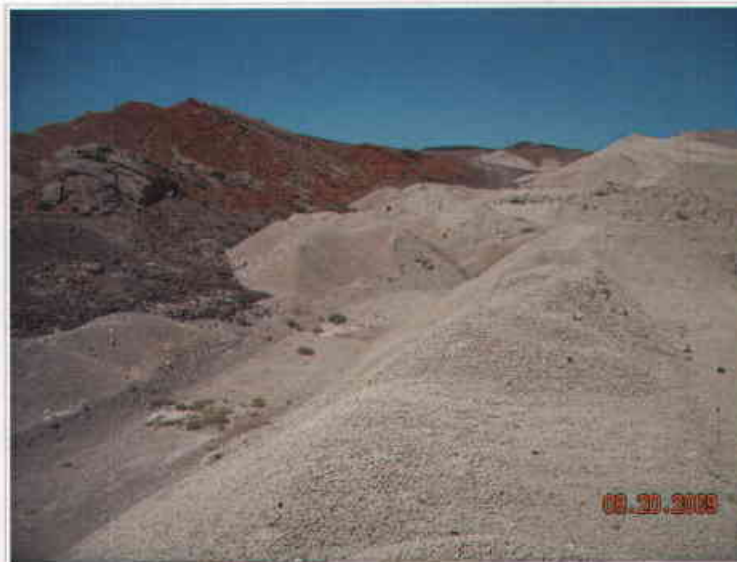
Designated overburden to the south.

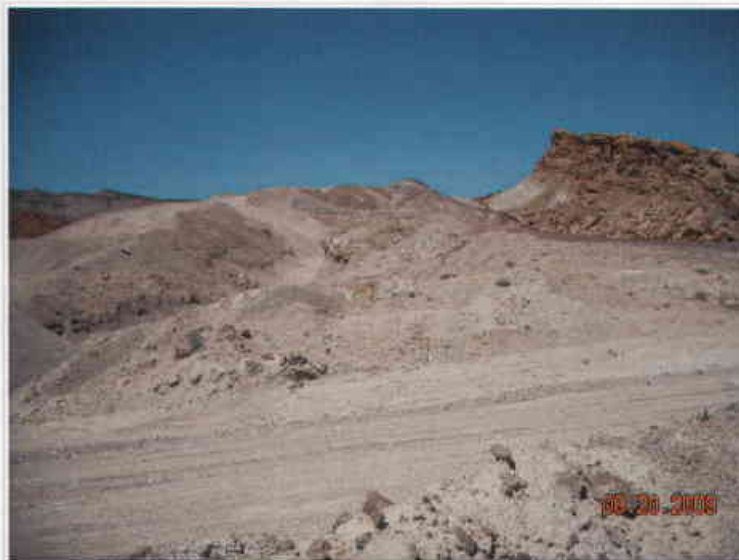
Central mining area and main disturbance.

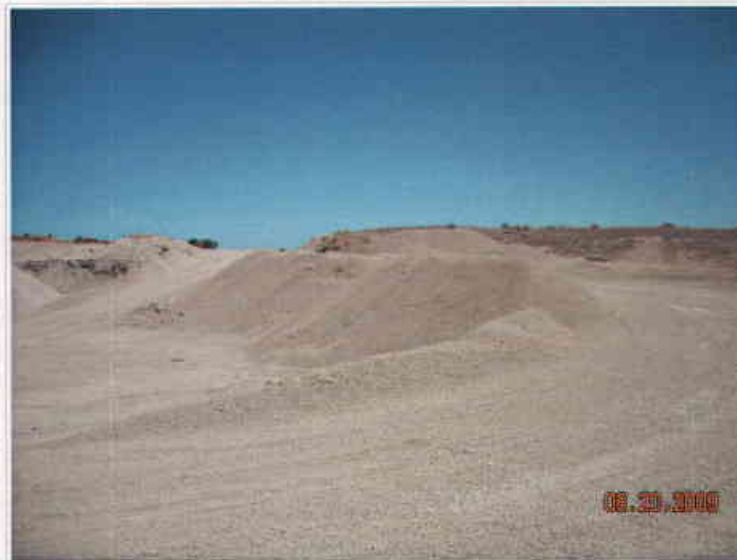
Access loop road.

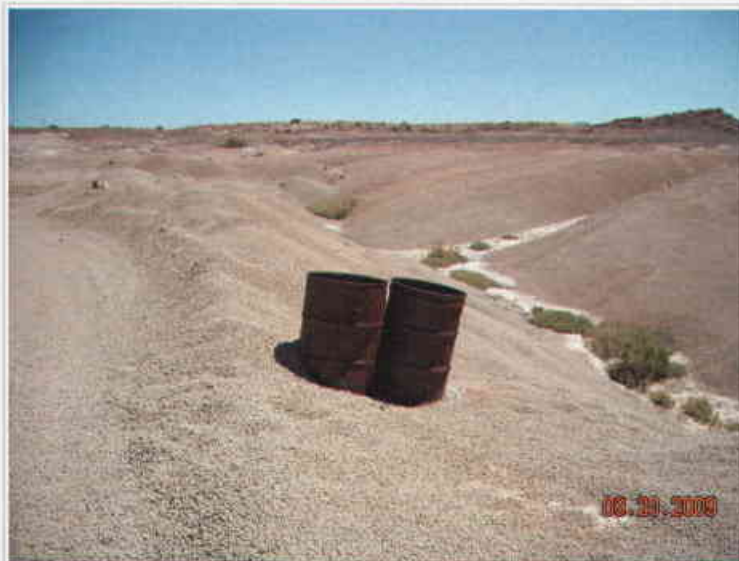
- 1) All fees are paid in full. The bond is not due for escalation until July 26, 2011.
- 2) Two large drums were found on site. They need to be removed if not being used.
- 7) Pretty much all of the overburden dumps lie at an angle of repose, they will need to be recontoured to match existing topography. There also is a large trench that eventually will need to be backfilled and graded to 45 degrees or less.
- 10) The entrance to the site appears to have been ripped, reseeded, and growing successfully. No other vegetation growth could be found within the mining disturbance, except maybe Shadscale.
- 12) I gathered GPS data for both the mine area and access road leading to the site. The total disturbance is approximately 9.44 acres.

Large empty drums. (Possibly trash that needs to be removed?)

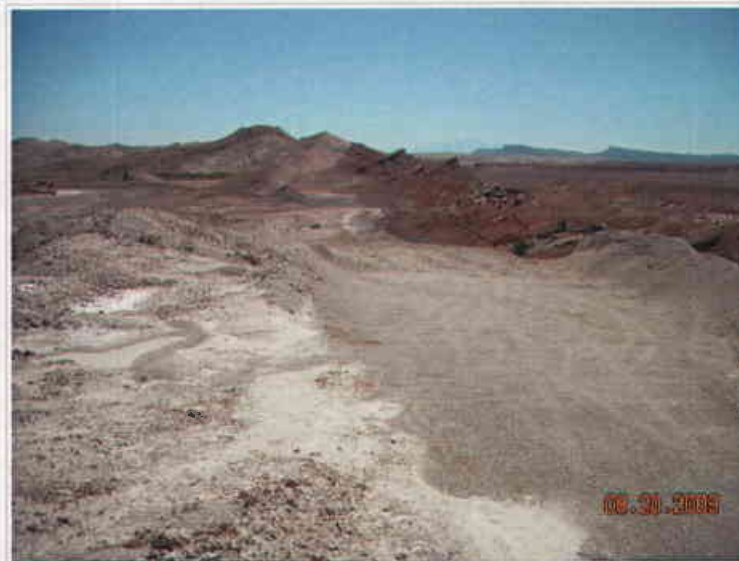
Top view of disturbance looking east. (No vegetation found.)

Conclusions and Recommendations: It is my recommendation all reposed dumps should be graded and recontoured to blend in with the existing topography. Revegetation efforts should also be made where possible to allow time for revegetation success. DOGM will continue to monitor this site when in the area.

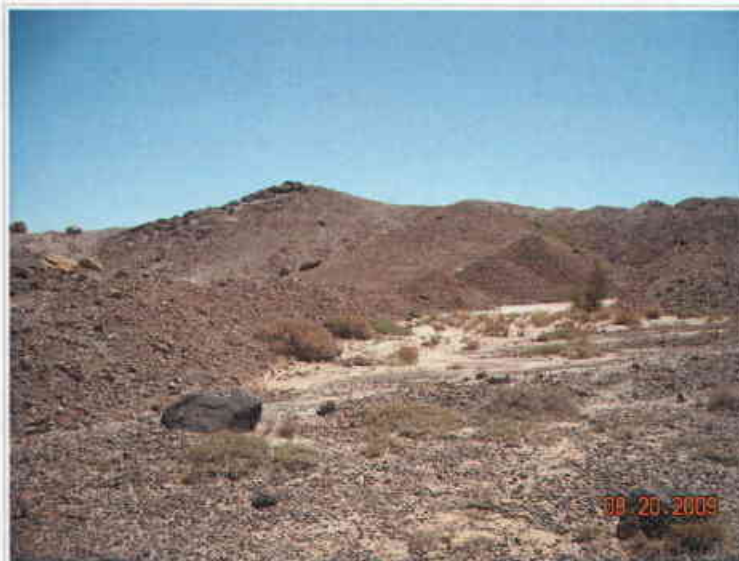
Side furthest west. (Some noticeable vegetation.)

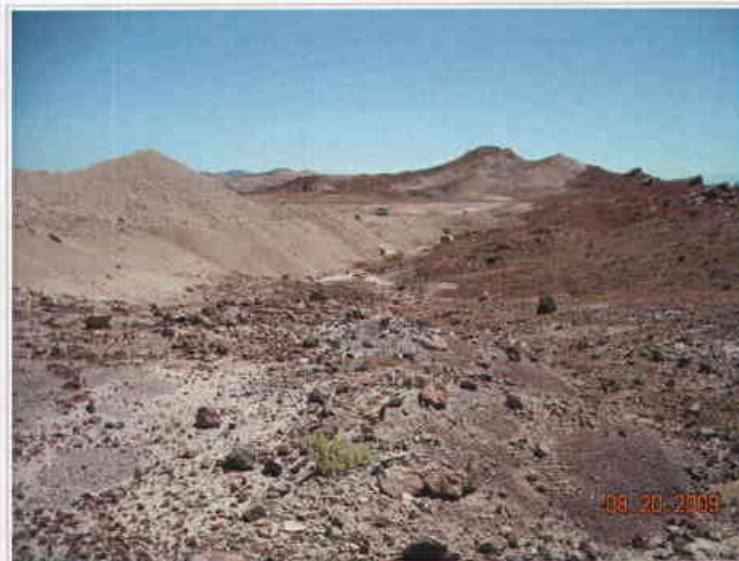
South side. (Eventual grade should match topography.)

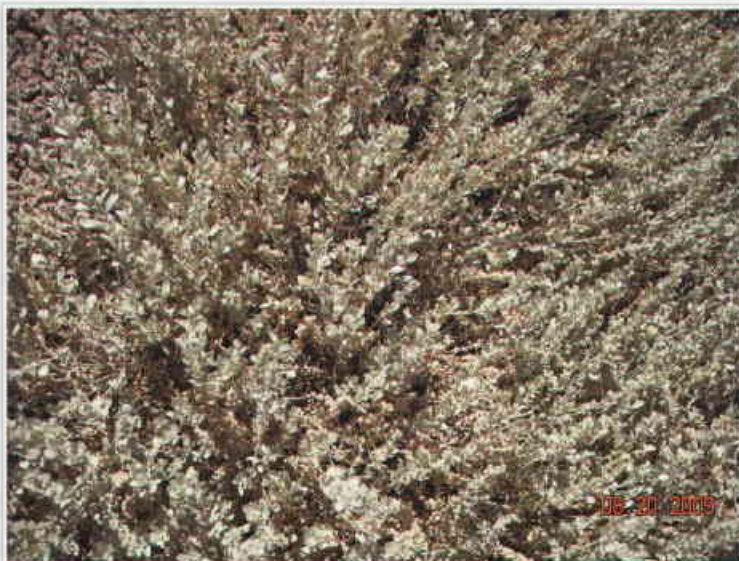
Shadscale.

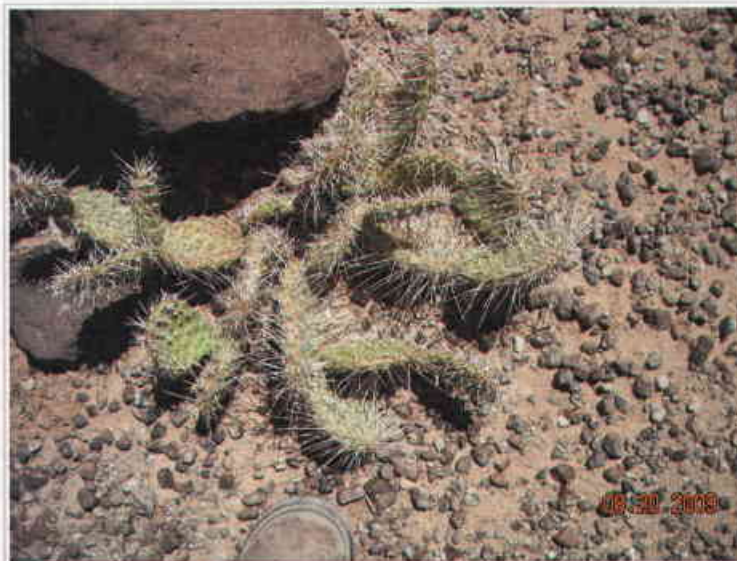
Prickly Pear Cactus.

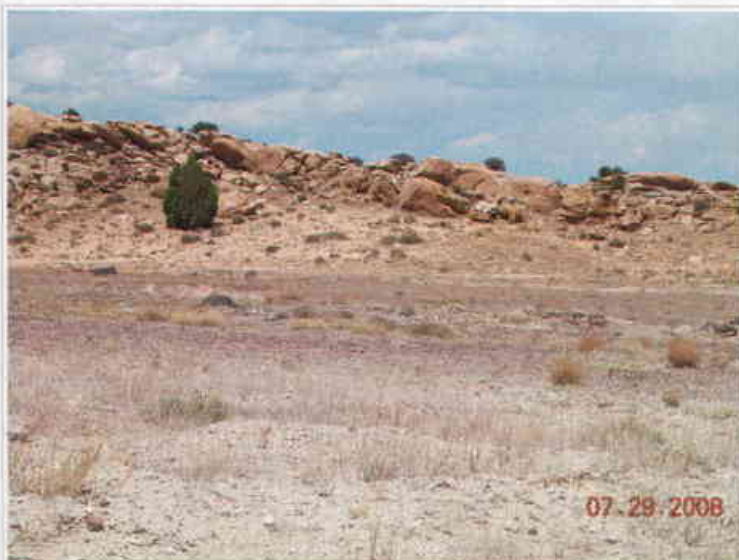
Indian Ricegrass, etc. (Photo taken in 2008.)

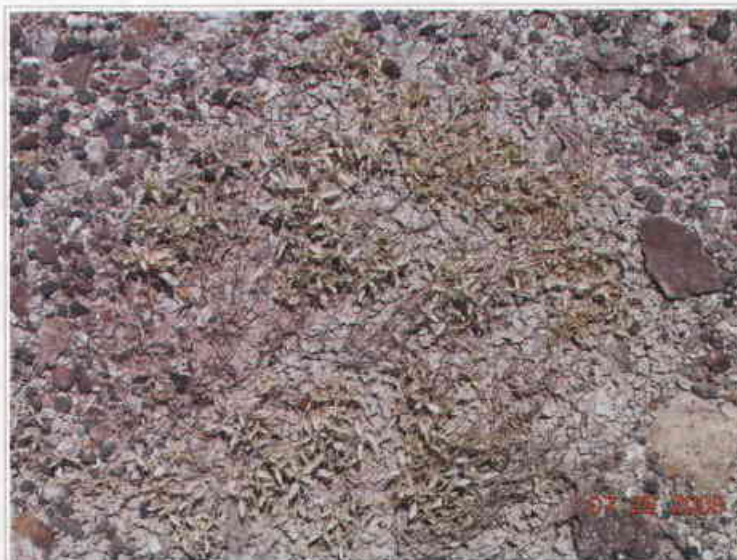
Castle Valley Clover? (Photo taken in 2008.)
